Long term investigation of Prelasti EPDM membrane for roofing Inspection no.3 – 37 years of service

Evaluated by Building engineer SBR Jan-Inge Bengtsson Constructech Sweden AB

<u>Roof 1</u>

Roof 2

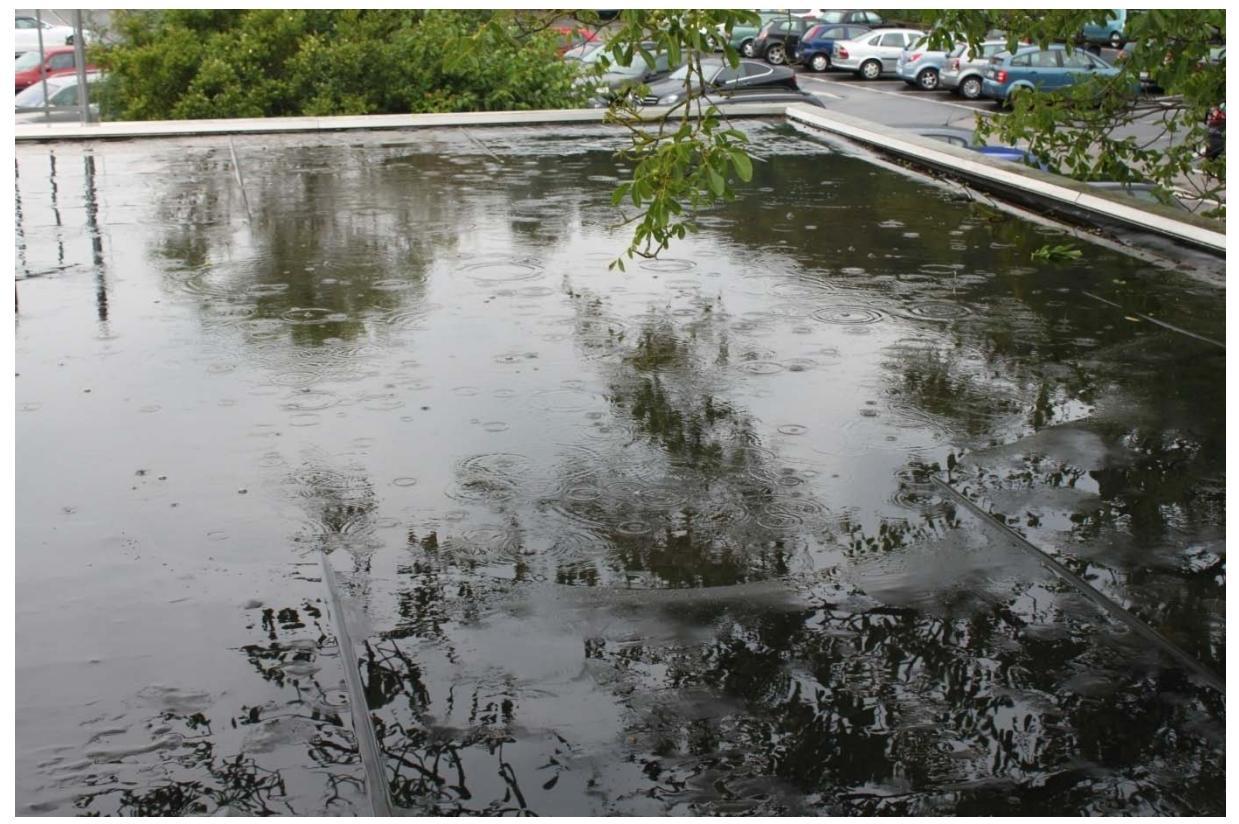
Picture 1.View of roof. Heavy rain shower.

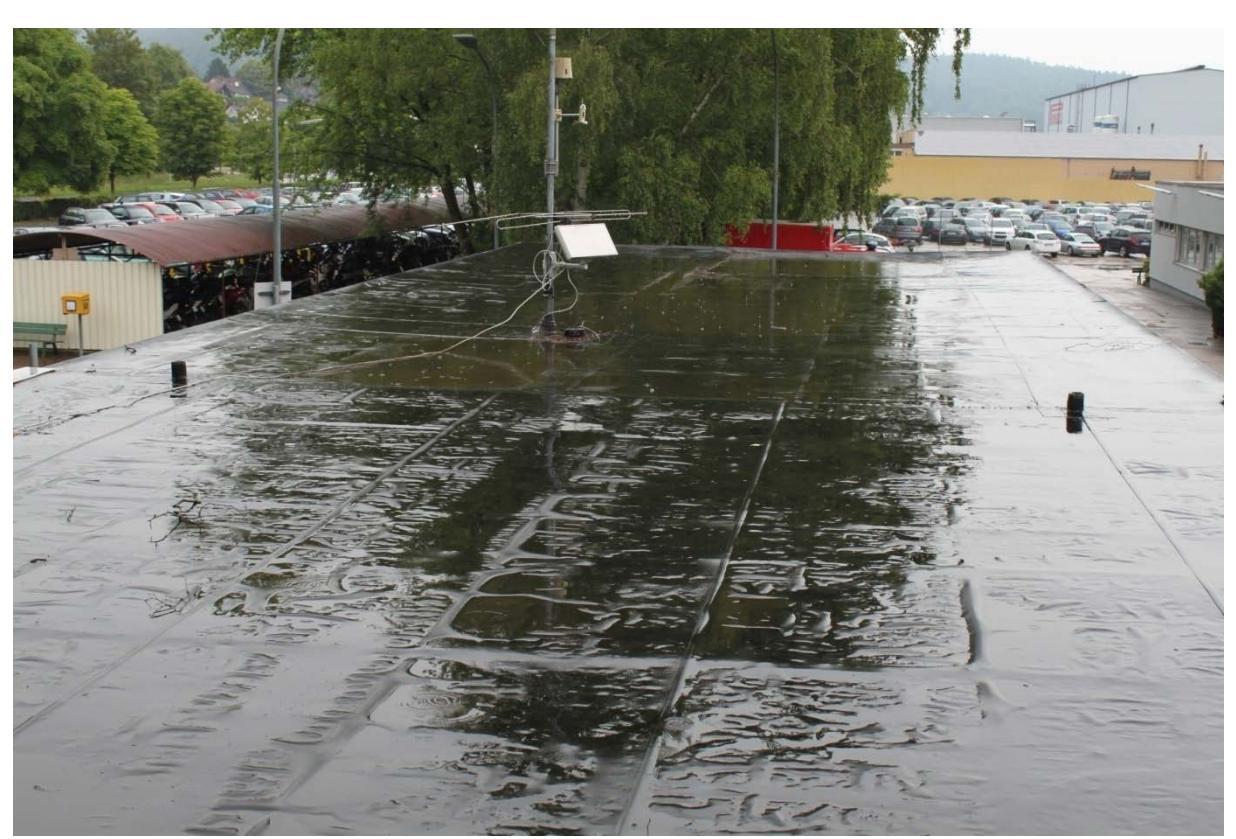
Picture 2. View of roof. Internal gutter and antenna.

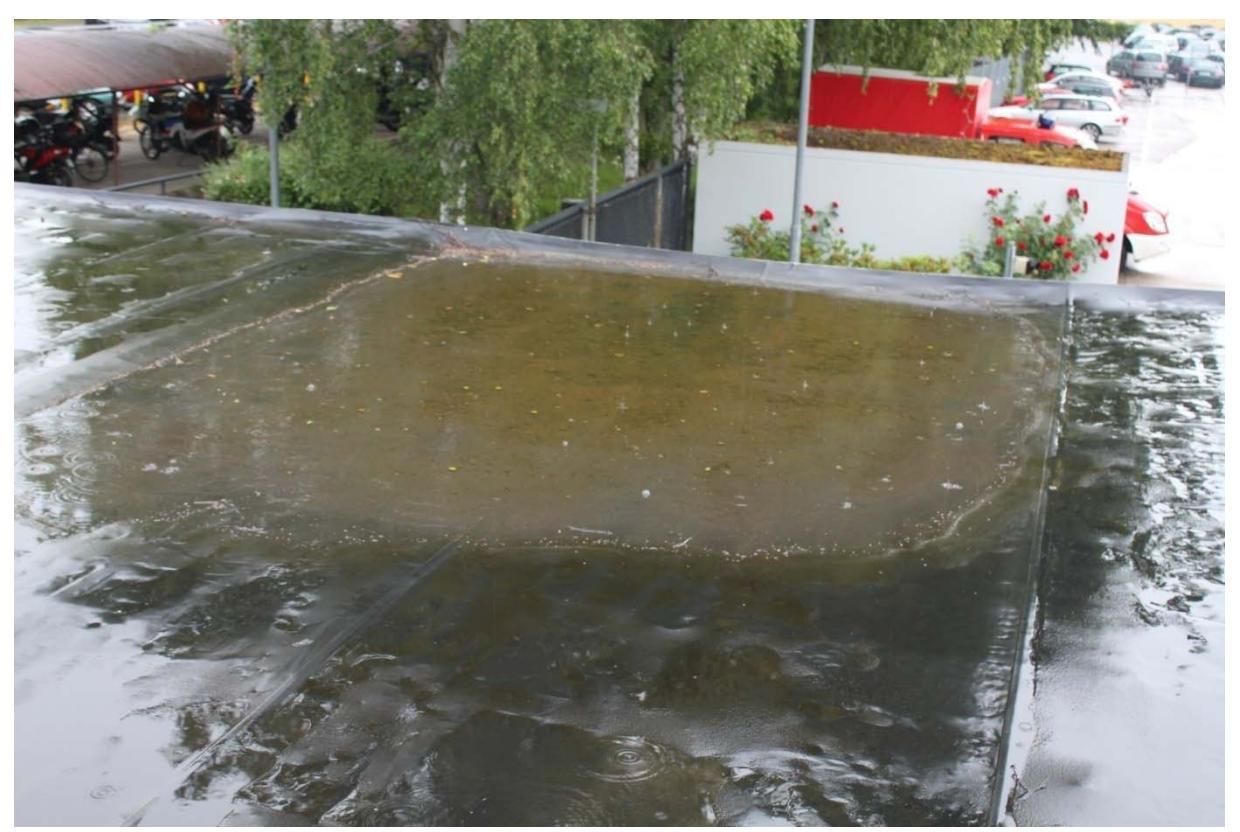
The low slope in combination with deflections in the substructure has caused relatively deep water puddles (6-8cm) with no possibilities to drainage, particularly on the north side of the roof.

Picture 3. Water puddle.

- Water pressure with changing water levels can lead to shrinkage and expansion of the membrane.
- Mud, algae and leaves can due to contraction cause micro cracks in the membrane.
- In winter time the ice as well as freeze/thaw can cause big tensions in the membrane based on abrasion.

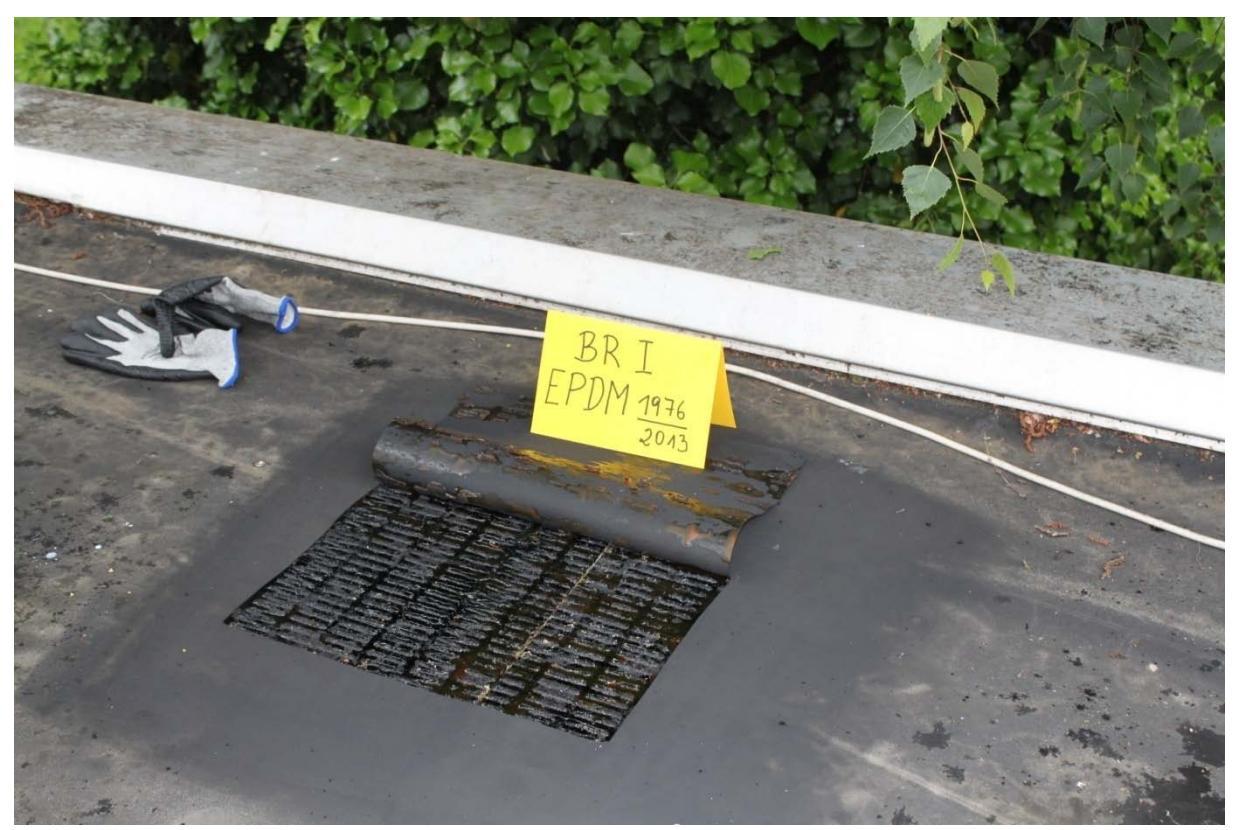
Picture 4. Test spot BR/I Mineral wool insulation

The visual inspection shows that even in spite of the hard outer conditions, the Prelasti EPDM membrane has not been affected in a negative way, during 37 years.

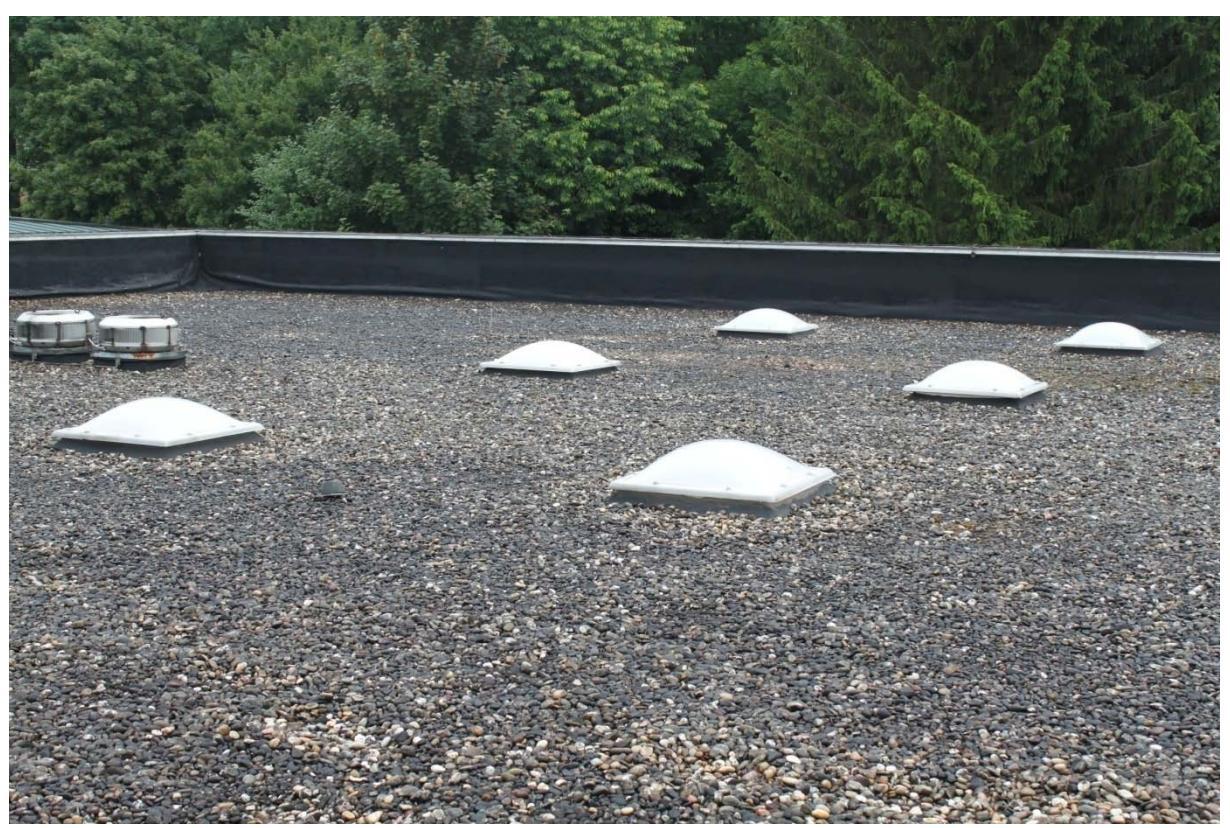
Picture 5. View of roof

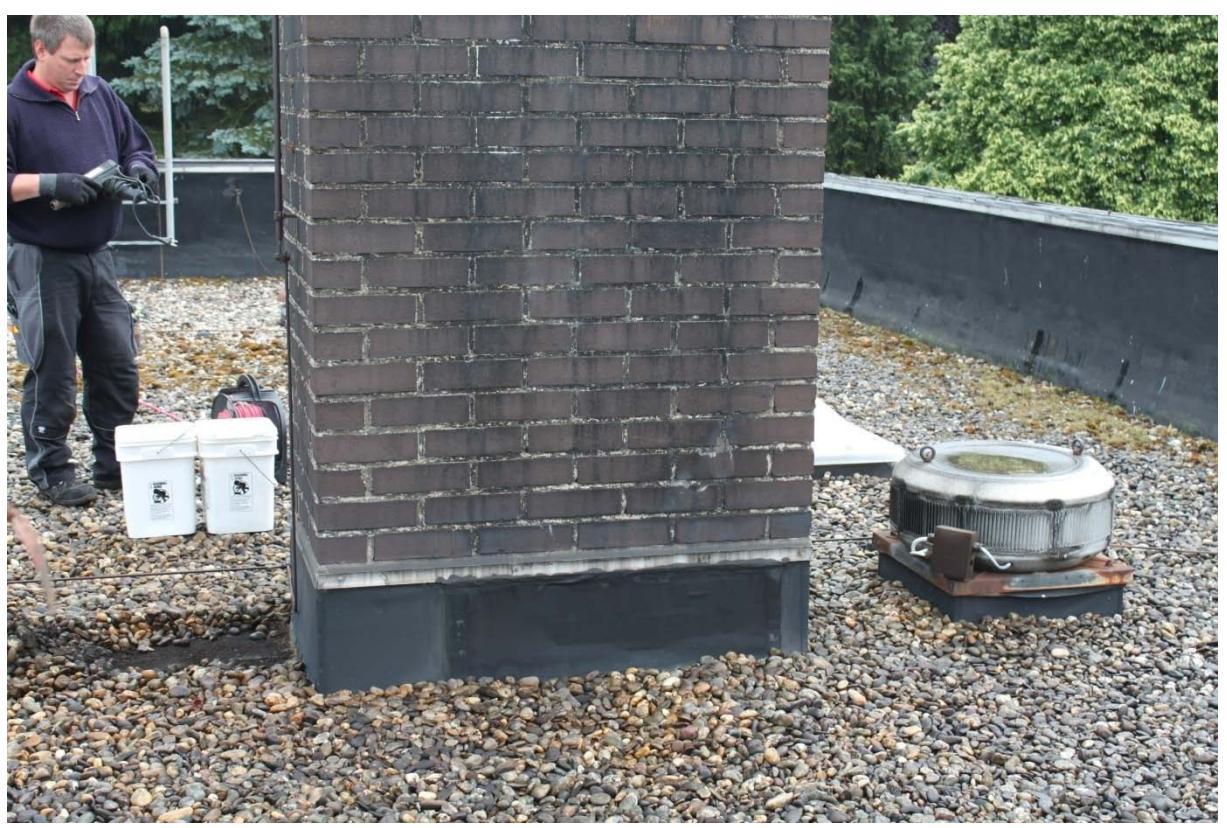
Exposed EPDM membrane in connections with a masonry chimney oriented in south west direction.

Picture 6. Masonry chimney. Note the dirt caused by soot and exhaust gases.

In this case, the membrane is exposed to pollution caused by the exhaust gases in combination with intensive UV-rays. Variations of temperature in the chimney have also caused condensation water with salt content which also has a negative influence on the membrane.

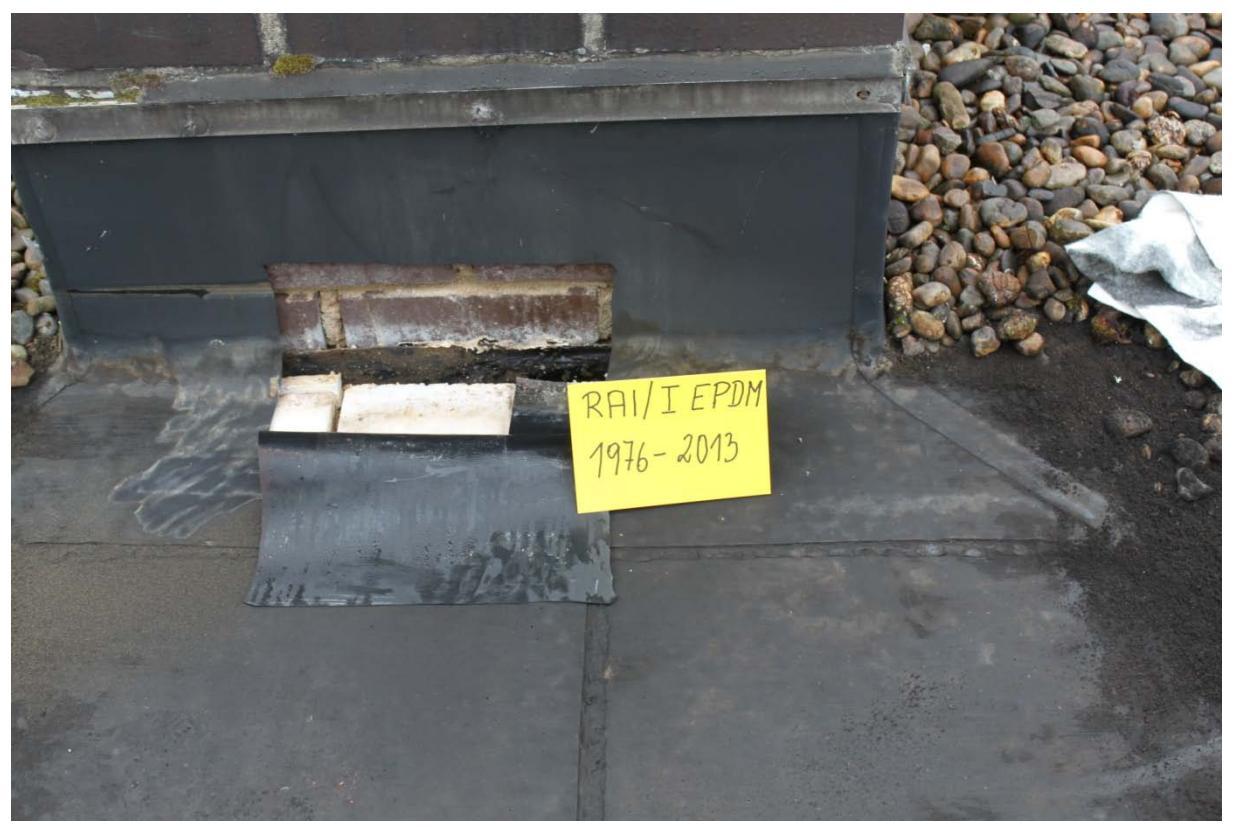
Picture 7. Test spot RAI/I connected to the chimney

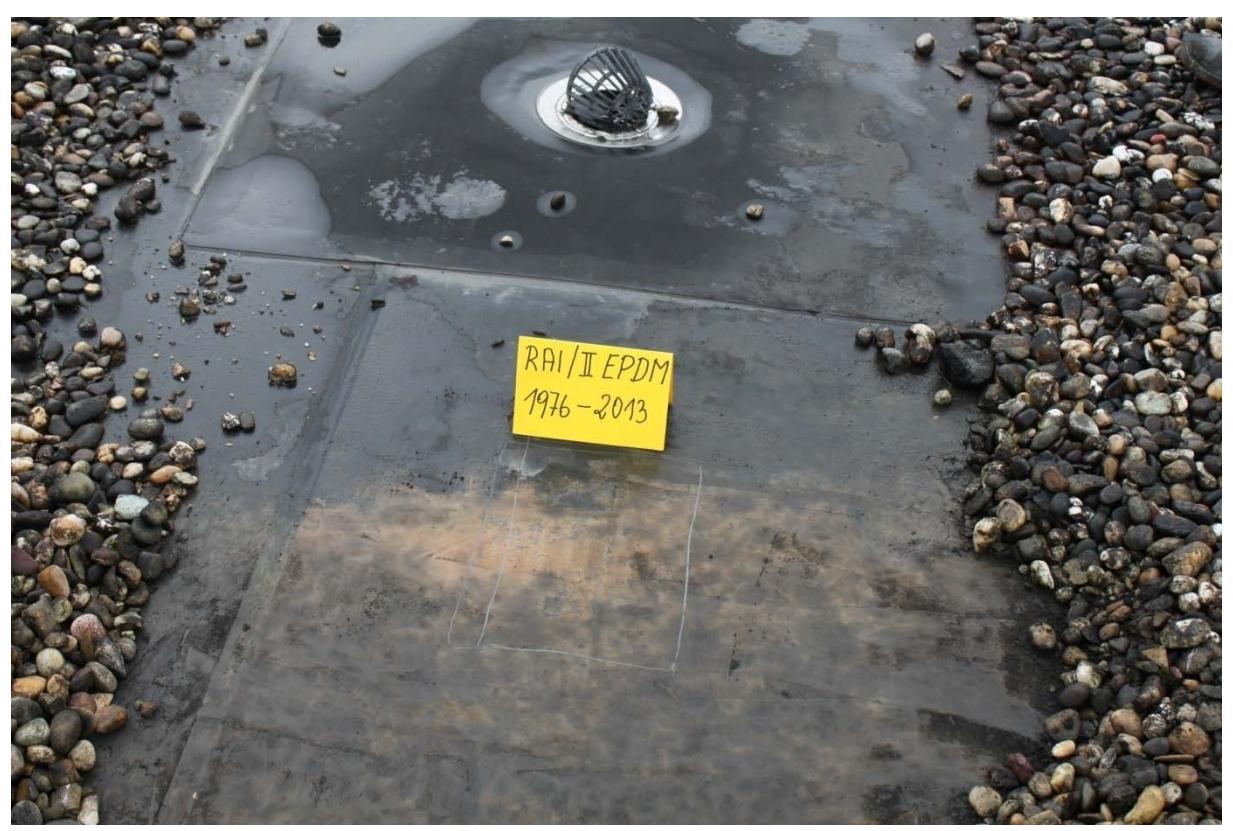
Picture 8. Test spot RAI/II connected to internal gutter without gravel.

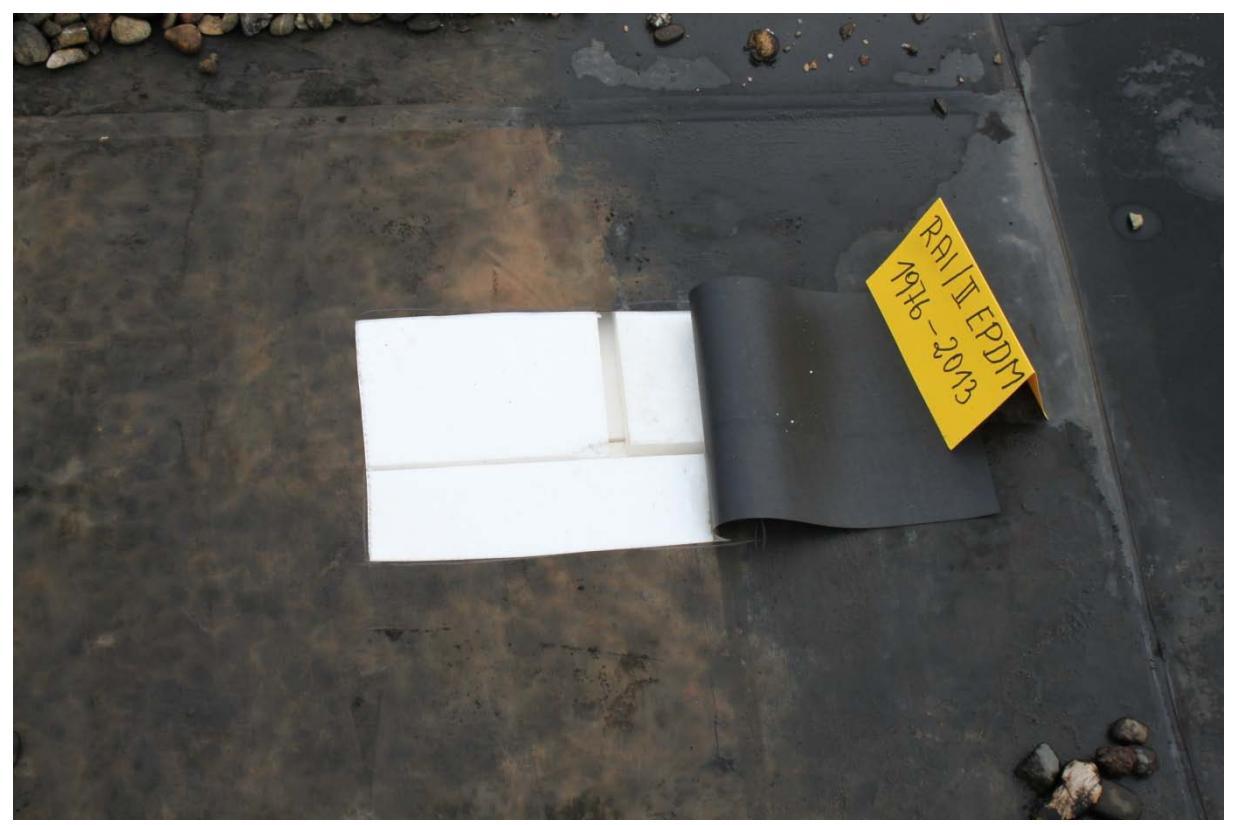
The unusually big joints between the insulation slabs are supposed to depend on shrinkage in the cellular plastic. This does not influence the membrane since it is loose laid on the insulation.

Picture 9. Joints of cellular plastic insulation.

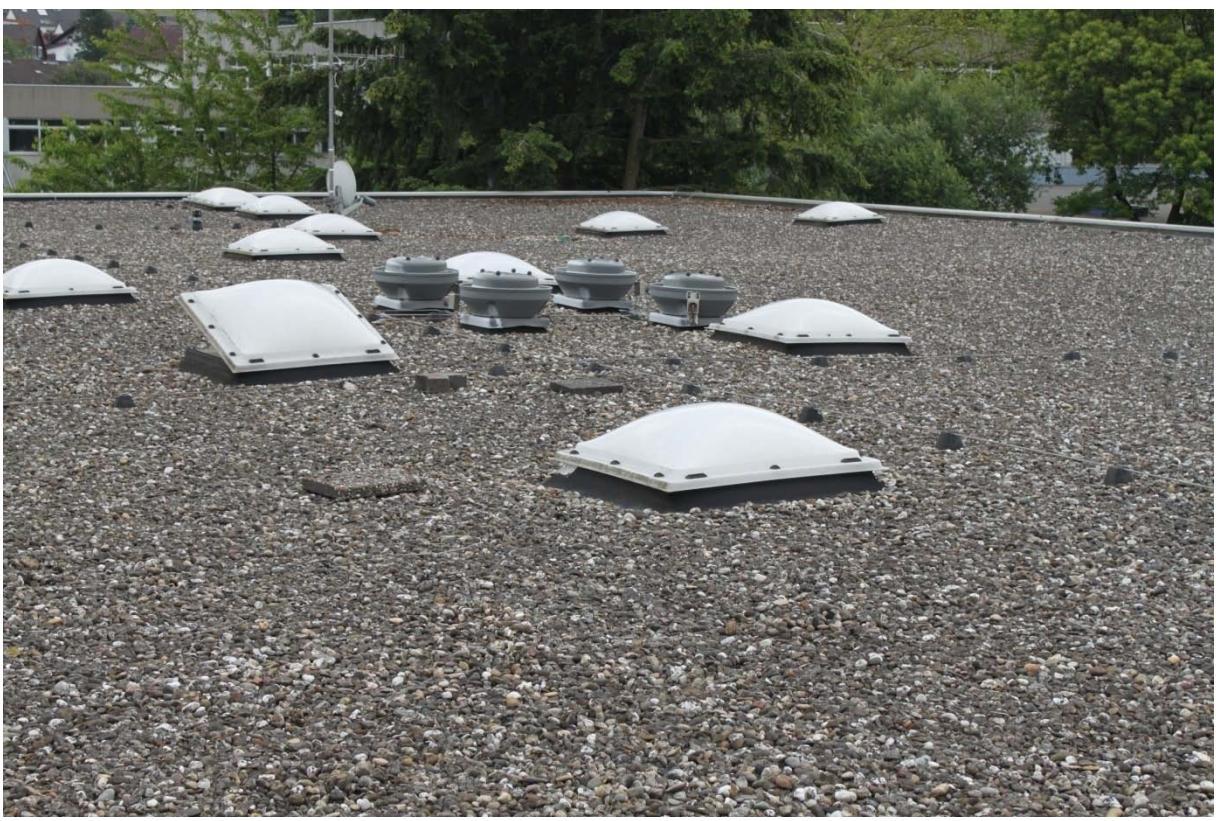
Picture 10. View of roof.

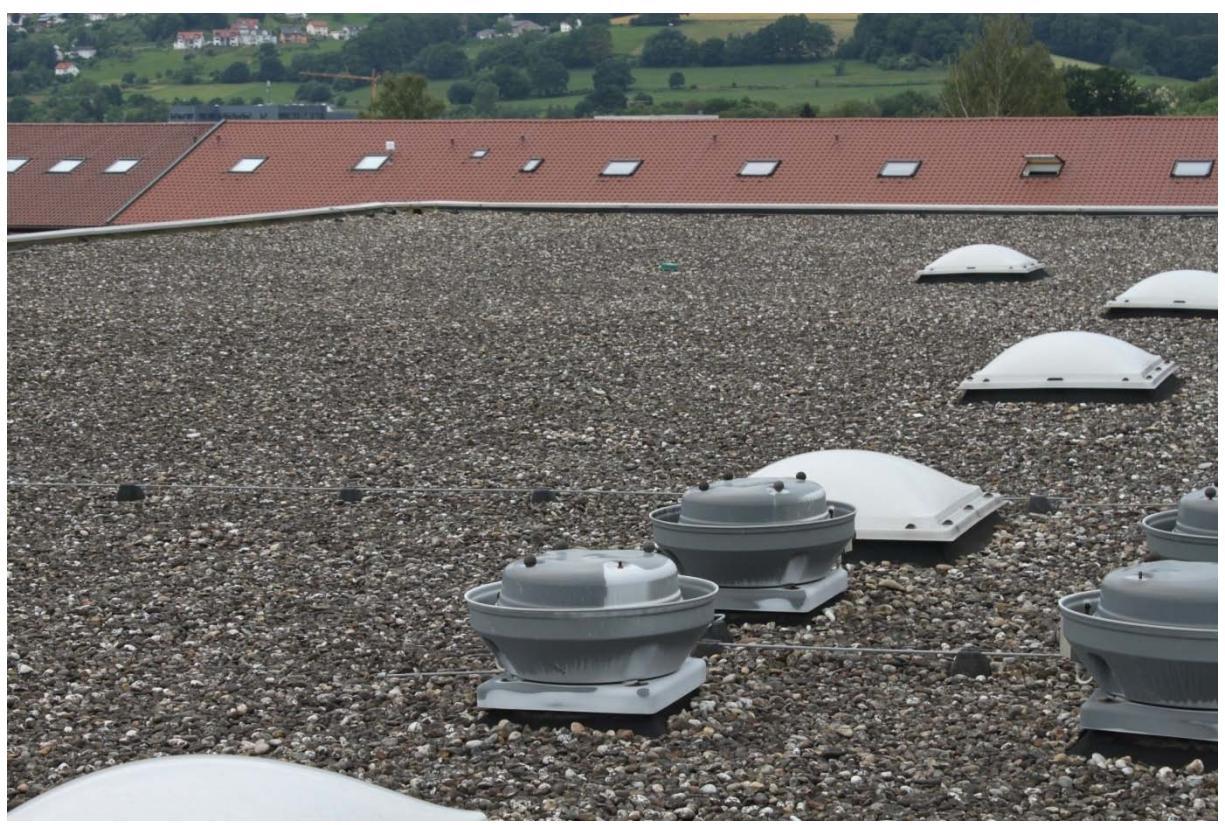
Picture 11. View of roof

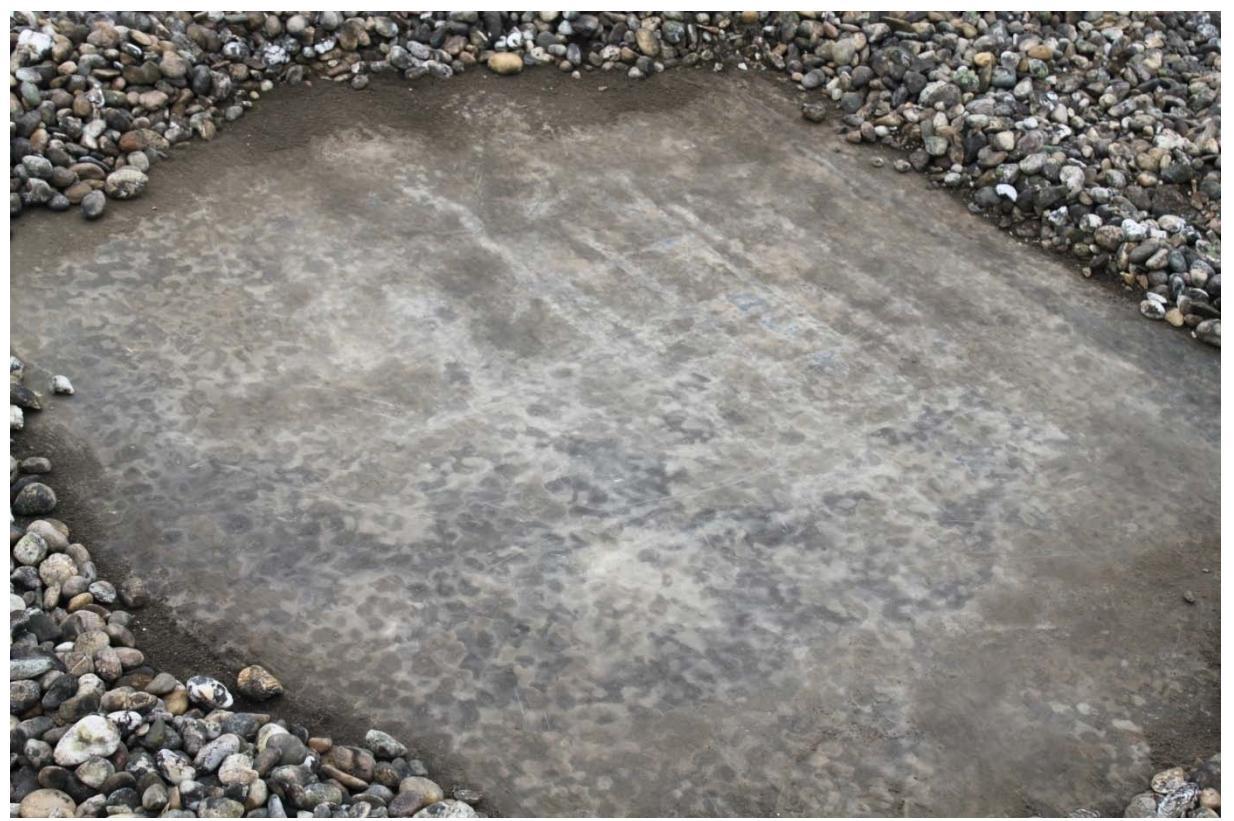
Examination was concentrated to certain spots where the membrane was polluted with a thin mud layer, impossible to remove and still remaining after the samples was tested.

Picture 12. Membrane polluted with mud.

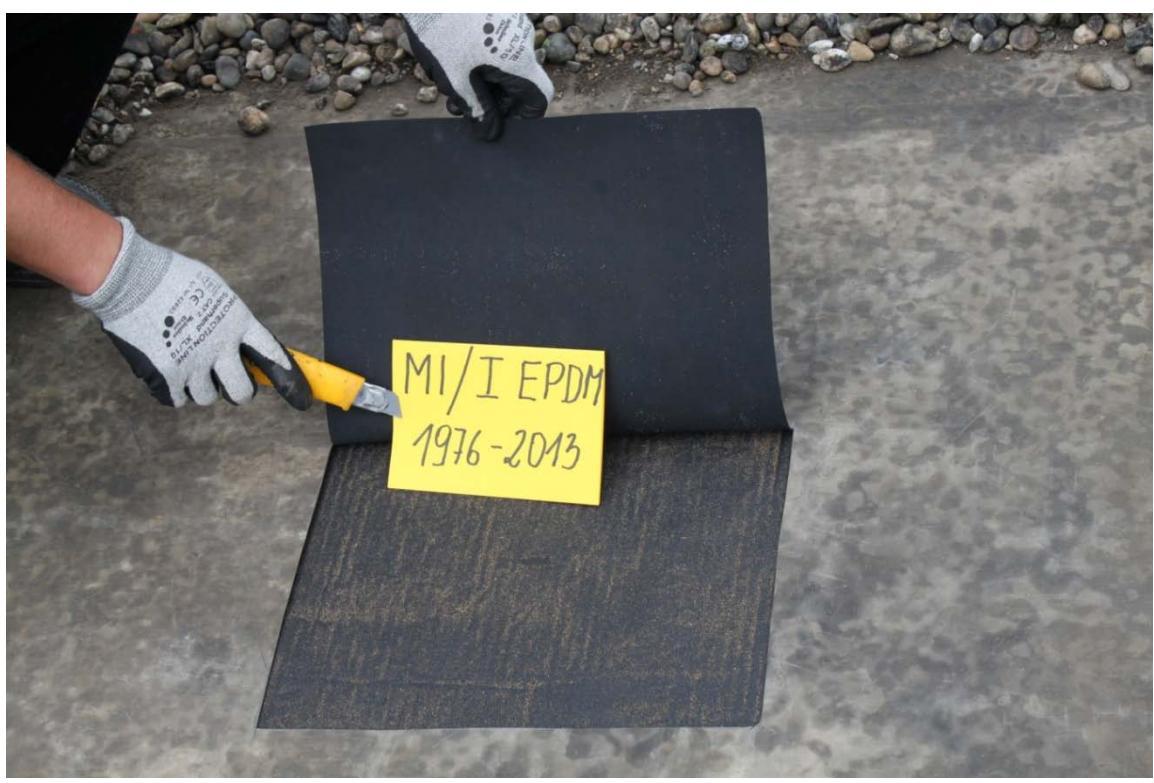
Samples are taken on a spot with polluted membrane in the mid zone of the roof.

Picture 13. Test spot MI/I

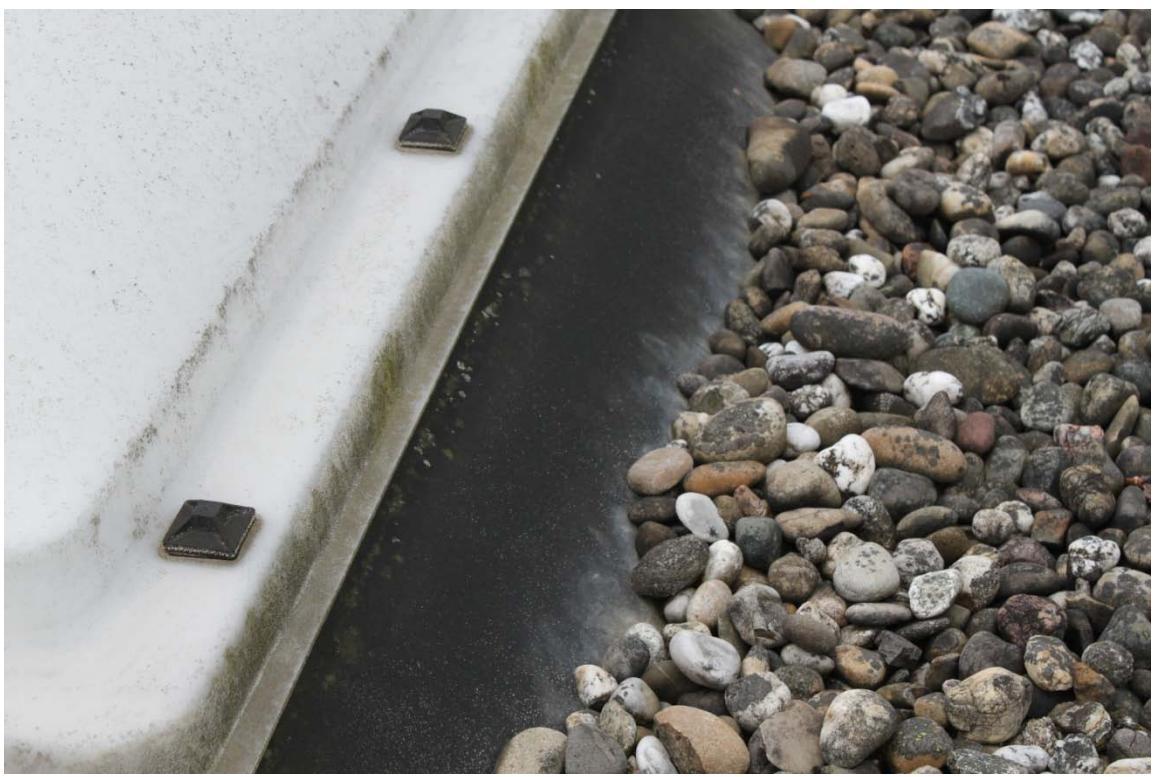
The unprotected Prelasti membrane at the roof lights were investigated visually without any remarks. The Prelasti membrane was slightly stretched at the roof lights but without negative influence.

Picture 14. Unprotected Prelasti membrane in connection with roof lights.
